The Physical Environmental Effects of Sand and Gravel Extraction in the Naugatuck River and Adjacent Floodplain

APRIL 1988

**US Army Corps
of Engineers**
New England Division

Internal Working Document EL-88-1

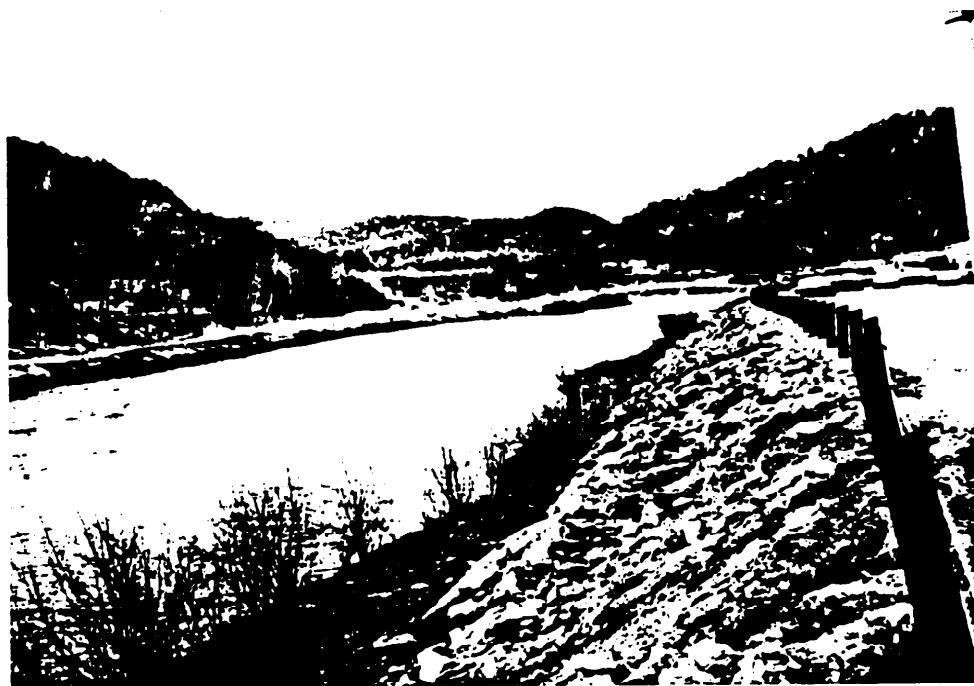
Figure 2. Looking downstream at Site 2, an abandoned, in-channel pit

At Site 2, between the Penn Central Railroad bridge south of Thomaston and the bend upstream of the Frost Bridge near Watertown, two large instream pits were excavated between 1963 and 1970 (Figure 2). Further, less extensive

excavation occurred in the channel between these original pits after 1970 and prior to 1980, by which time activity within the channel ceased. Approximately 5100 ft of river channel have been disturbed by gravel mining at this site. Average width in the reach, measured from aerial photography, has increased from 175 to 225 feet and average depth has increased by over 6 feet. The maximum pit depth shown on a 1980 hydrographic survey of this site was ~ 25 feet. Between 1951 and 1963, gravel bars between Thomaston and the site grew slightly and were destabilized (i.e., detached from the banks or stripped of a significant amount of vegetation), probably as a result of floods in 1955. Bars within the site limits and for several thousand feet downstream were degraded or more vegetated in 1963 than in 1951. During the first mining phase, upstream bars stabilized, bars at the site were extensively mined, and bars below the site were degraded or removed entirely. Upstream headcutting at the site has been prevented by a bedrock outcrop, which acts as a grade control (Figure 3). Except for small gravel deposits upstream of the site at the mouth of Branch Brook, there was little change in bar morphology, and a slight increase in bar vegetation, from 1970 to the present.

The volume of material removed from Site 2 was estimated based on a hydrographic survey of the site from 1980, assumptions of the pre-mining bed elevations based on 1963 aerial photography and a reasonable bankfull channel conveyance. At least 770,000 cubic yards of material would be required to return this site to a channel geometry equivalent to that observed in 1963. It is excavations of this magnitude which pose the most serious threat to water quality and hence to migration of anadromous salmonids. Time of travel studies during summer low flows of 20-40 cfs reportedly give a mean water velocity through the site of ~0.03 fps; average velocities at the most heavily excavated cross sections would be an order of magnitude lower.

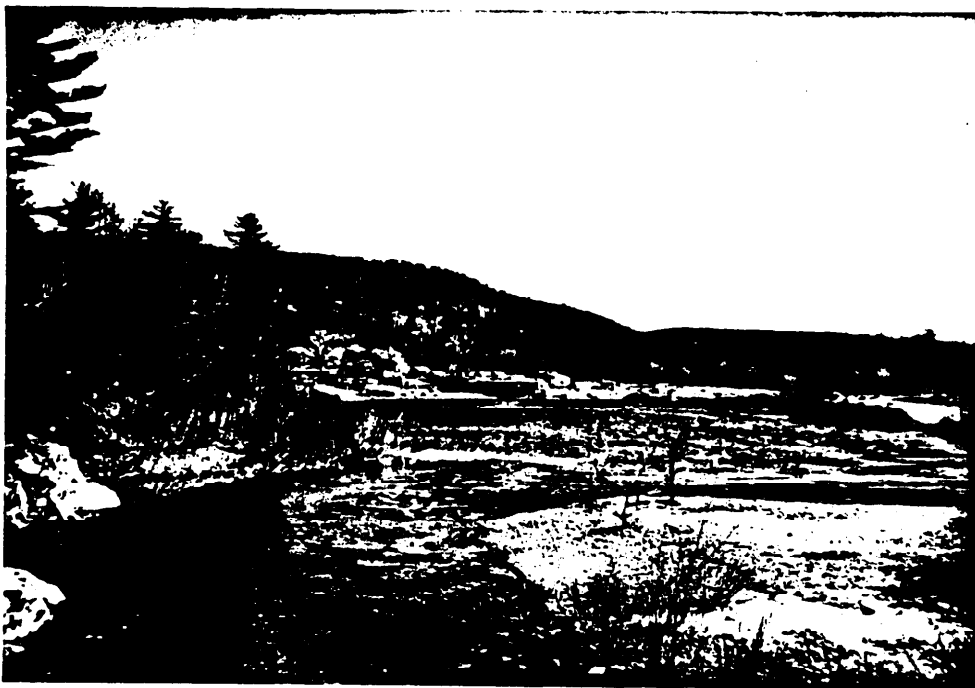
Figure 3. Downstream view from head of Site 2. The diagonal riffle seen in the middle of the photo is supported by a bedrock outcrop which functions as a grade control.

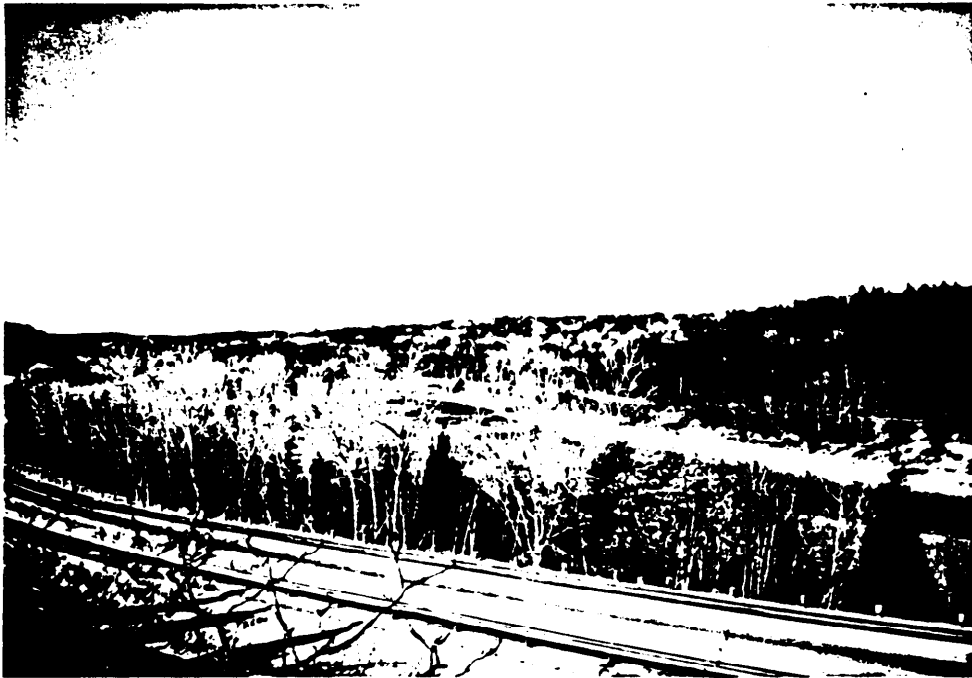
Figure 4. Site 5, flow is from left to right. Note mid-channel bars.
Route 8 is in the foreground

Less information is available for Site 5, located on the outside bank of the bend immediately below Kinneytown Dam (Figure 4). The area below the dam

apparently received a great deal of sediment following the 1955 floods; the gravel bars at this location have been steadily degrading since that time, although interpretation of these features from photography is confounded by substantial water diversion at low flow at the dam site. Mining began between 1951 and 1963; a rectangular pit 800 ft long and 180 ft wide is plainly visible on the 1970 photos. The pit borders were slightly modified prior to 1980 (by fluvial action?) and were unchanged from 1980 to 1985. The current pit depth is not known. Channel bars between the dam and the site have successively degraded and become more vegetated since 1963. Channel changes upstream of the dam and downstream of the site are minimal and are primarily related to: redistribution of sediment during the 1955 flood; the low head dam (which was probably breached during the flood); construction of Route 8 (immediately uphill, west of the site); and construction of a channelized reach downstream as part of the Ansonia/Derby local flood protection project. Channel geometry and flood profiles calculated for the Seymour Flood Insurance Study (U.S. Department of Housing and Urban Development (HUD) 1978) show a relatively flat water surface above the pool during flood events; the dam should be an effective barrier to bedload movement as a result.

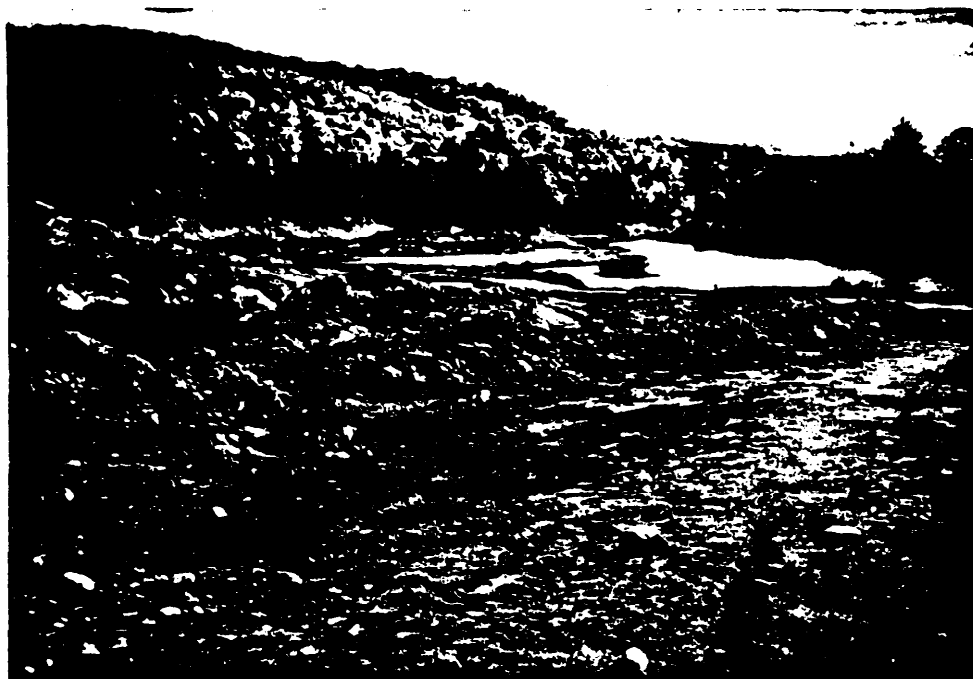
Figure 5. Aggregate extraction from riparian pit at Site 1.

Site 1 is located on the left bank of the river at the end of Wildcat Hill Road, between Torrington and the Thomaston Dam (Figure 5). Mining of outwash terraces above the floodplain is in evidence on the earliest aerial photographs and expanded continuously throughout the study period. The entire floodplain was disturbed by the time of the 1980 photography, which also showed the first evidence of mining in the wet. In addition, the width

of the channel had doubled (from ~130 ft to ~260 ft) between 1970 and 1980, apparently as a result of mining. The 1985 photography shows three large and two small water-filled pits on the floodplain and additional bank retreat of ~40 ft. These observations from aerial photography and site visits show that there has been instream mining at this site with concomitant channel widening; the channel also appears to have deepened by an unknown amount.

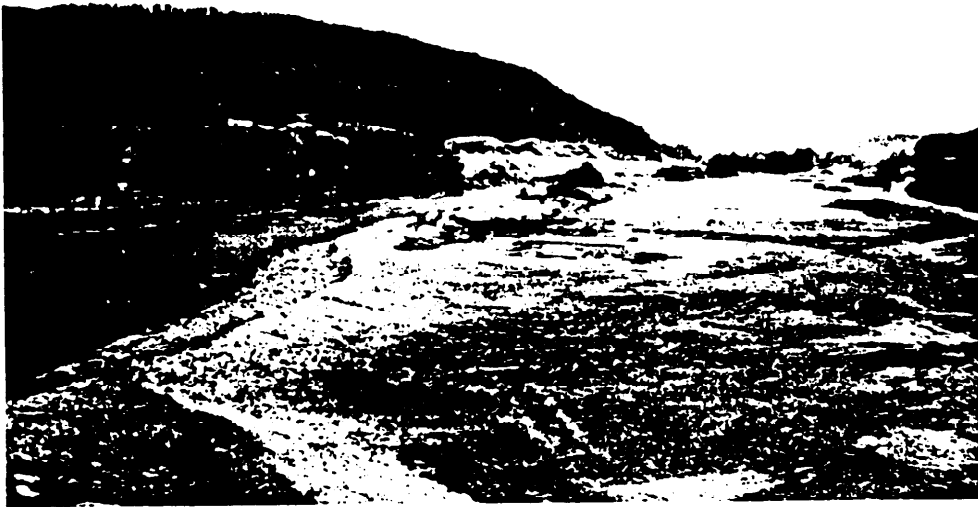
Figure 6. Looking downstream, Site 3 is on the right and the Naugatuck River is on the left. Note island at upper end of pit

Sites 3 and 4 were evaluated together, as they are on alternate bars/floodplain in a contiguous channel reach. Site 3 is on the right bank 800 ft below Pine Bridge, between Beacon Falls and Seymour (Figure 6). It has two wet rectangular pits totaling ~3200 ft in length and 300-400 ft in width; pit depth was estimated at 20-30 ft (F. D. Shields personal communication). Mining in the dry began at this location sometime between 1970 and 1980, with the pits excavated shortly thereafter. Apparently, the 50 ft wide berm separating the pits from the channel was overtopped near the upstream end during high water in 1982 ($Q_{pk} = 15,600$ cfs at the USGS gage 1.4 mi. upstream at

Beacon Falls), creating a small island 500 ft south of the upper pit margin. In addition, the pits drain through a breach in the berm 2600 ft downstream of the upper margin; this outlet controls the water elevation in both pits, as the pond elevation was approximately 8 ft below river elevation at the upstream end during a site visit in April, 1986. [This cross-valley hydraulic gradient should be considered if and when measures are undertaken to permanently stabilize the berm.]

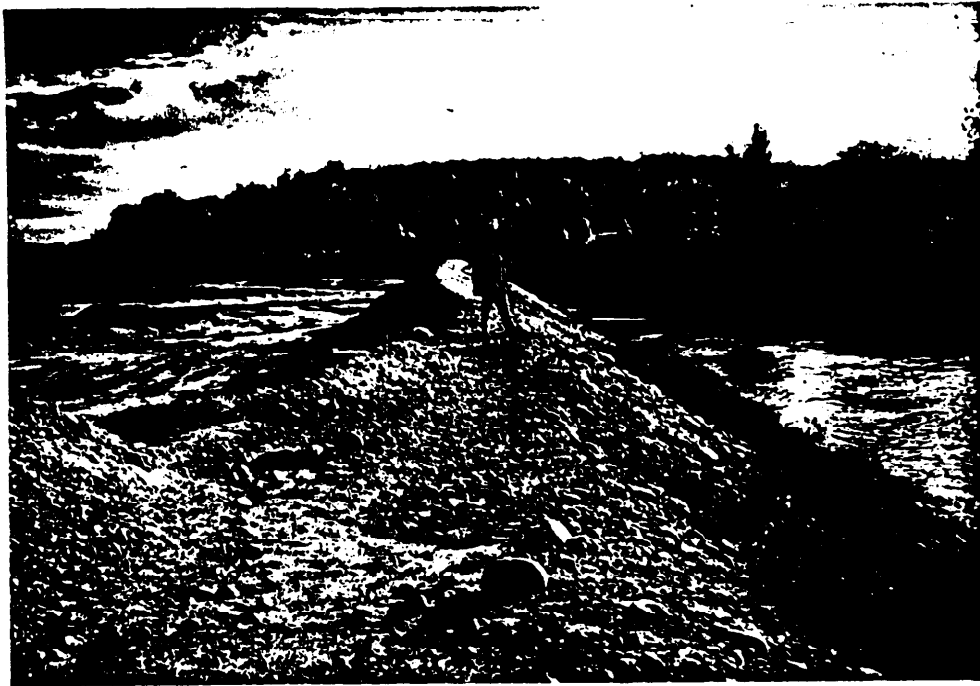
Figure 7. Site 4, high banks of stockpiled material separate the channel and the pit

Site 4 is an oval pit, 920 ft on the north-south axis by 375 ft east-west, located on the left bank downstream of a trailer park complex, which itself is downstream of Site 3 (Figure 7). A small, dry pit is visible at the upstream end of the site in the 1970 photos, with the full pit excavated between 1970 and 1980. The 1980 photographs show the pit open at both upstream and downstream ends; any buffer was probably breached in the 1979 peak flows ($Q_{pk} = 18,700$ cfs at the Beacon Fall gage). This site, too, is now separated from the channel by a 50-60 ft wide, 20 ft high berm composed of unconsolidated sandy gravel (median grain size = 25mm).
